# Finish Notes™

The newsletter of architectural finishes investigation  
from Frank S. Welsh company

Volume 4, Number 1 Fall, 1996

## On the Right Track – Grand Central Terminal

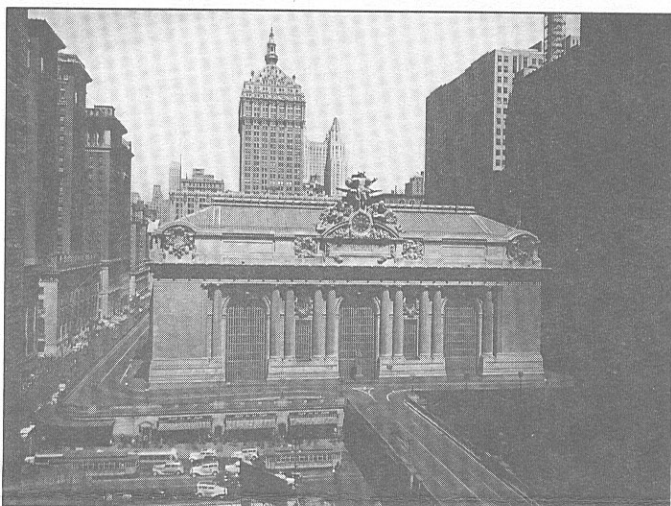
Grand Central Terminal, 42nd Street (south) facade, ca. 1929

The exterior is constructed of Stony Creek granite and Bedford limestone, always exposed in its natural finish. The building's mass is relieved by decorative finishes in the form of

painted metalwork and naturally finished wood, the latter protected by several layers of shellac. Where ferrous metals are used on window sash, door frames, grilles, pilasters, and marquee framing and brackets, they were originally painted light grayish olive to resemble antique oxidized bronze. However, its most recent coating conforms to an International Style aesthetic and resembles dark bronze anodized aluminum.

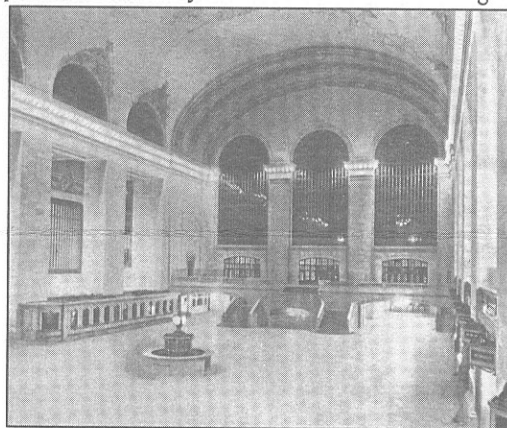
Express Concourse, looking west, 1913. Note the interplay between the monochromatic wall surface, dark painted windows and elaborate sky ceiling.

If buildings have hearts, the Express Concourse, where earth meets sky, has a vitality all its own, apart from the bustle of rail travel. From the floor of Tennessee marble to the vaulted ceiling with its constellations and Milky Way 125 feet above, the Express Concourse is an example of public architecture as an ennobling and edifying device. Because of the ceiling height and a surrounding balcony, the walls divide themselves into three distinct areas, from the standpoint of surface finishes. The lowest range is polished Botticino marble and the middle range, from balcony floor to cornice, is the same Caen stone material used in the Waiting Room. The cornice and end wall tympani are covered with hard surface plaster, coated with an oil base paint decorated to resemble stone.

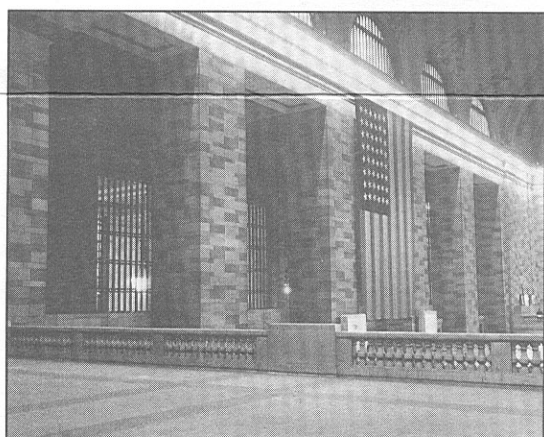
Angle view of the south wall of the Express Concourse from the east balcony, showing the imitation Caen stone walls painted to simulate different colored blocks of stone, ca. 1943.

Perhaps, the most important question we were asked to answer was to discern the nature of the original surface finish for the imitation Caen stone walls. A bit of detective work helped. A 1913 advertisement for "Knickerbocker Caen Stone Cement" claimed it was noted for its "shade of color," and, as stated, early

photographic evidence suggested a monochromatic color scheme. But photos from a slightly later period showed a strong contrast in coloration, which suggested a different surface treatment. Paint samples from the Caen stone were analyzed in the laboratory, with the polarized light microscope, and the original unpainted scheme was verified. We identified titanium dioxide white pigment, a product unavailable commercially before 1917 and not

widely used until the 1920's. This finding, coupled with the documented history that the station received a major face lift in the '20's, enabled us to be confident of our conclusion that the original Caen stone wall surfaces were unpainted.

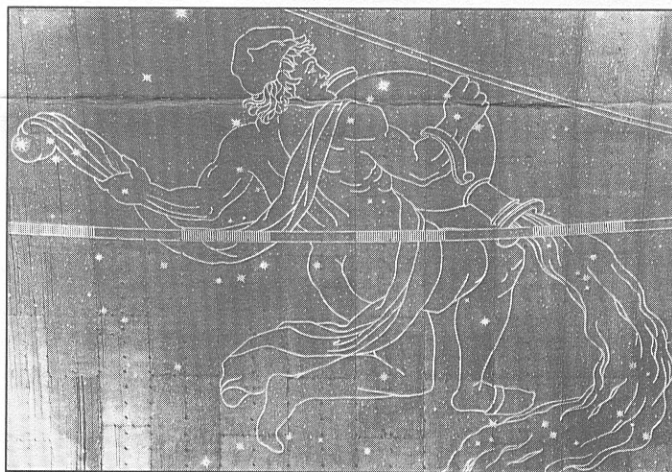
1989 view of the southeast corner of the Sky Ceiling, showing the stars and figure of Aquarius on the cement plaster panels installed in 1945.

Another important question focused on the famous Sky Ceiling. Installation of a new cement plaster panel ceiling and the repainting of the constellations were described in *Railway Age Magazine*, September 29, 1945, but there was much debate about the original surface that survives beneath it and the appropriate restoration route. The client removed a small triangular panel and exposed the original plaster and paint. The original ceiling was badly deteriorated. The best samples from this area were located under the original gold leaf decoration. With the aid of the stereomicroscope, we color matched the best samples and used the polarized light microscope to analyze both the pigment composition and the binder of the blue paint. The original Sky Ceiling's light blue paint was made with calcium carbonate, ultramarine blue, and chromium oxide green, bound together in a tempera medium.

The 1945 cement plaster panel ceiling, now covered with grime, initially carried four oil base paint coatings with varying tints of light blues and greens, applied in sequence to give the illusion of depth. In addition, the cerulean blue was stippled with daubs of different colors to heighten the sky effect when viewed from a distance. Cleansing of the star constellations and zodiac signs is underway as part of a two year, \$175 million restoration project and we are supplying Munsell Color Samples to the painting contractors for use in matching the new paints.

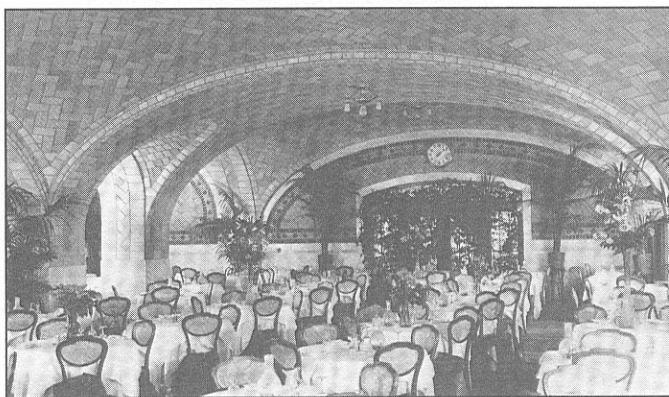
The Oyster Bar in 1913. Ceiling and vaults are Gustavino tile with recessed panels of brick laid in a basketweave pattern.

Even those who know of Grand Central only by hearsay have probably heard about the famed Oyster Bar. In the unique design of the station, service facilities and restaurants were located around the perimeter of the building and accessible via a series of interconnecting ramps. The Oyster Bar is located on an intermediate level under the Waiting Room. The shallow vaulted ceiling and multiple arches give the space a grotto-like effect, which is enhanced by the use of cream colored Guastavino tiles on the ceiling and walls. Metalwork on the door and transom frames conforms to the treatment of metal in other parts of the building - it is painted a light grayish olive to resemble oxidized bronze.

Another point of major interest to the architects and planners was the original condition of the ramp leading to the Oyster Bar. The walls of this low ceilinged passageway are polished Botticino marble, but the plaster ceilings, painted light yellow to match the marble, are not original to the building. Early photographs show the Oyster Bar Ramp as a grand space lit by immense spherical chandeliers. In 1927, when the ticket office administrative area was extended southward over the ramp, the archways were infilled and painted to match the marble surrounds.

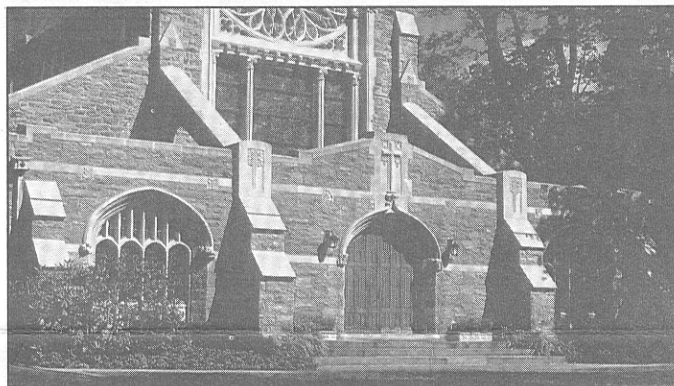
Church of the Redeemer (1881), Bryn Mawr, PA, showing the 1911 addition of the one story narthex. The west front doors are visible in the photograph and are shown prior to restoration.

The Church of the Redeemer in Bryn Mawr, Pennsylvania is an 1881 Gothic Revival gem whose exterior decorative scheme was significantly changed by a 1911 addition, incorporating a narthex and porte cochere on the west end of the building. The central doorway and two side entries feature paired wood panel doors, with iron hardware, which, over the years, were damaged by exposure to sun, rain and an interior radiator leak. In the mid-20th century, the overall visual effect was altered when the doors were stripped, repaired, restained and varnished. Last year, when restoration was authorized, an investigation and microanalysis by Frank Welsh disclosed that originally the doors were treated to resemble limed oak, a finish which makes the wood look bleached and aged. Restoration of this multi-step refinishing process of staining, filling and varnishing was recommended.

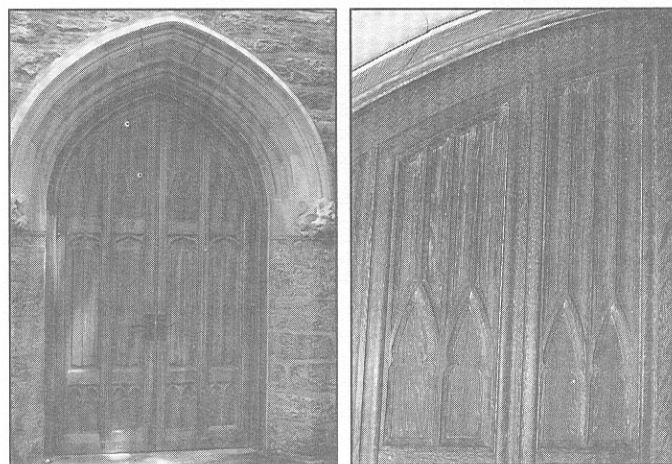
These doors show the effect of the finishing process known as liming, which gives open grain wood the appearance of age from weather-bleaching.

At Redeemer, the liming process began with stripping, followed by sanding and the application of a very dark brown stain. An off-white paste varnish was then rubbed on and wiped off, so it filled only the open wood grain. Two very thin coats of semi-gloss marine varnish were brushed on, sanding between each coat, to seal the finish and protect the doors from the weather. Application of a coat or two of dark paste wax may be used as a final step to tone the whiteness of the filler.
